APOLLO PROGRAM

FINAL FLIGHT EVALUATION REPORT APOLLO 9 MISSION

JUNE 1969

D2-117017-6
FLIGHT EVALUATION REPORT - APOLLO 9 MISSION

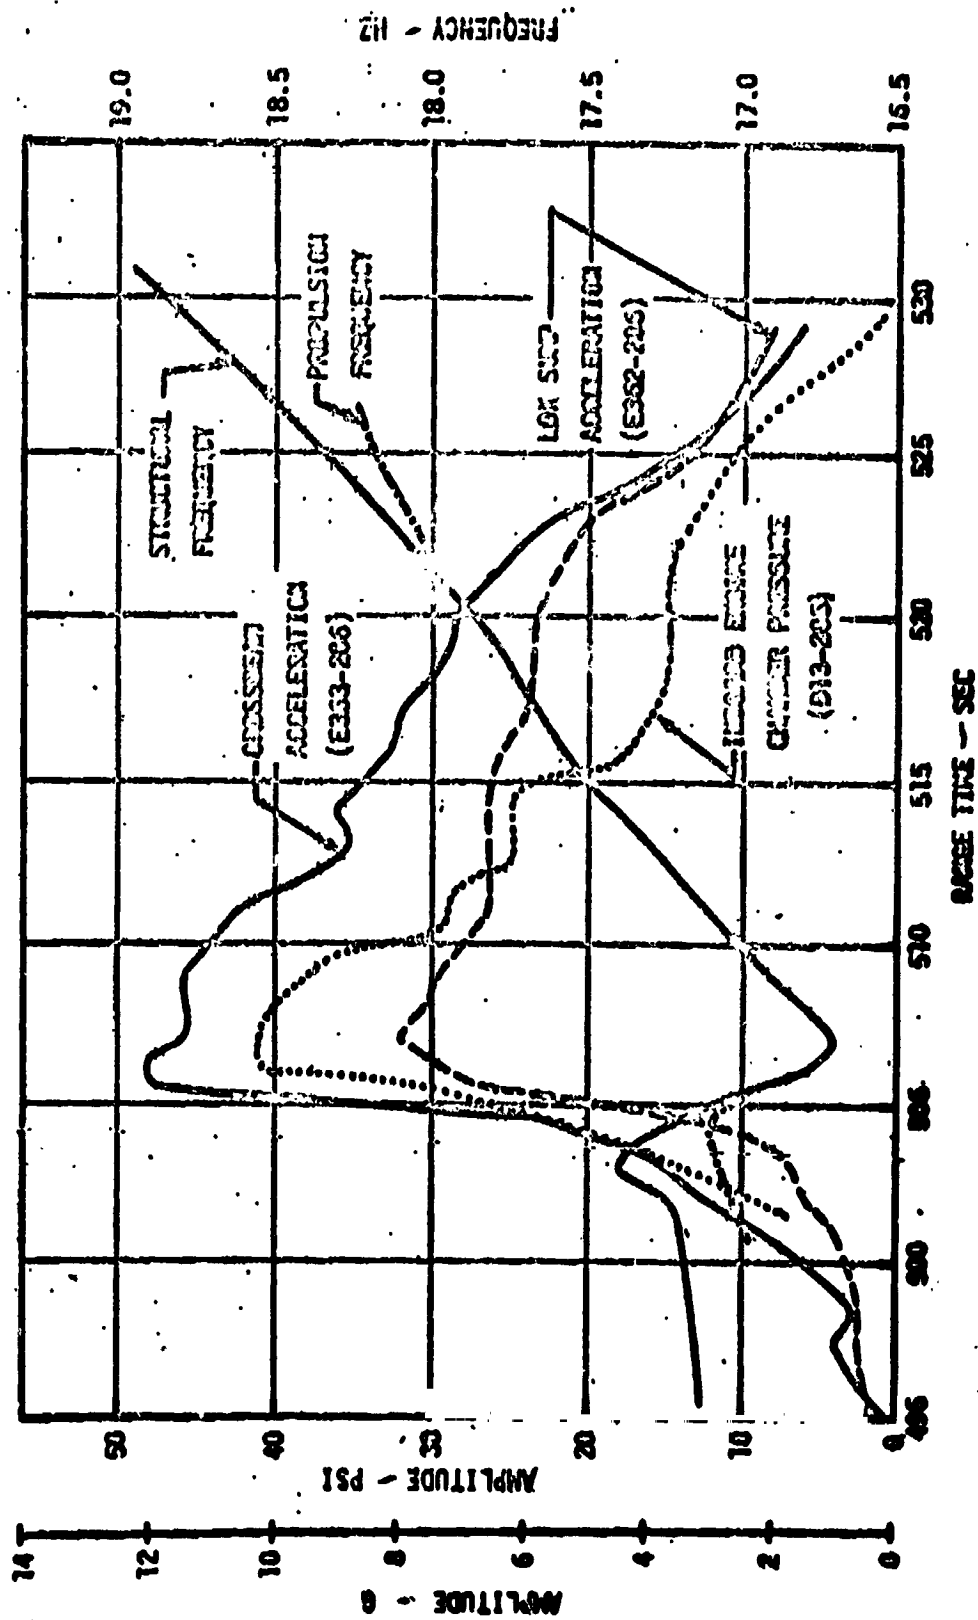
FIG. 2.2.1-1 AMPLITUDE AND FREQUENCY DURING S-II OSCILLATIONS

TITLE: S-II PROPULSION/STRUCTURE OSCILLATIONS

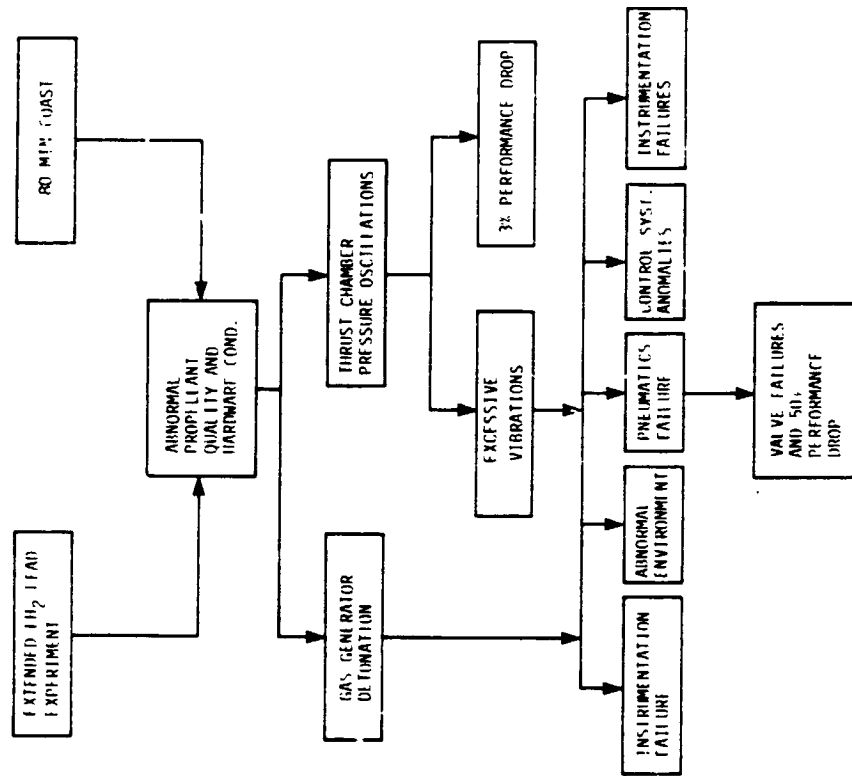
FIG. 2.2.4-1

TITLE: S-IVB THIRD BURN PERFORMANCE VARIATIONS

FLOW DIAGRAM, SUMMARY OF S-IVB THIRD BURN ANOMALIES

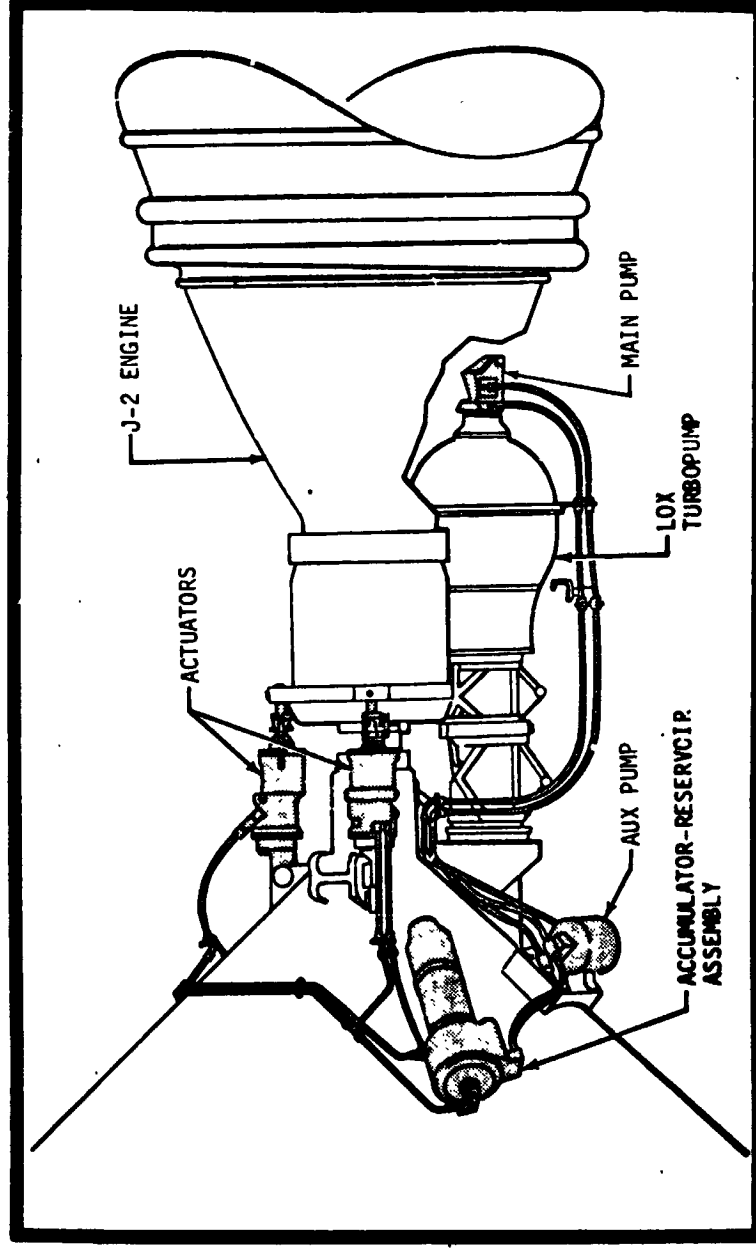
S-IVB FLIGHT CONTROL SYSTEM HYDRAULIC COMPONENTS
FIG. 2.2.4-2

TITLE: S-IVB THIRD BURN PERFORMANCE VARIATIONS
